July 2021

## **Environmental Biodegradation Evaluation and Time-Lapse Video: New WinCup Holdings, Inc., Phade® PHA Marine Biodegradable Straws**

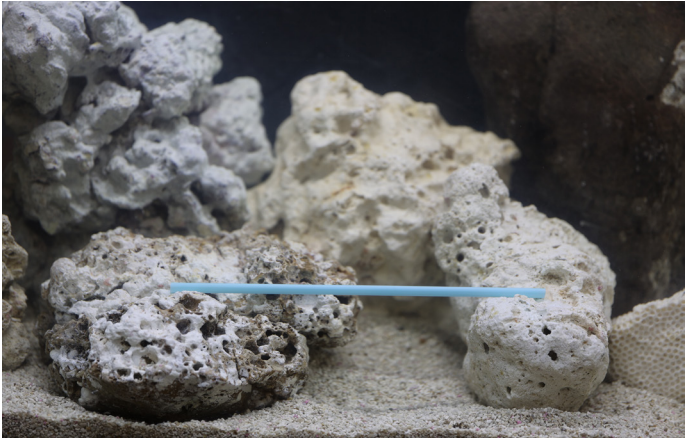
Tank 1	Tank 2
<p><b>4/6/21</b></p>

<p>First day of the straw in the tank.</p>	<p><b>4/2/21</b></p>

Keypoint Intelligence and the Marine Tank Specialist delayed the start of the project in Tank 1 because it was not showing optimal conditions to sustain marine life. On April 6, the second of the randomly selected phade straws was placed on top of the water in Tank 1, after which the straw also sank to the bottom right away and was placed on the rocks by Keypoint Intelligence technicians. Unfortunately, one of the clownfish was lost within the first 24 hours.

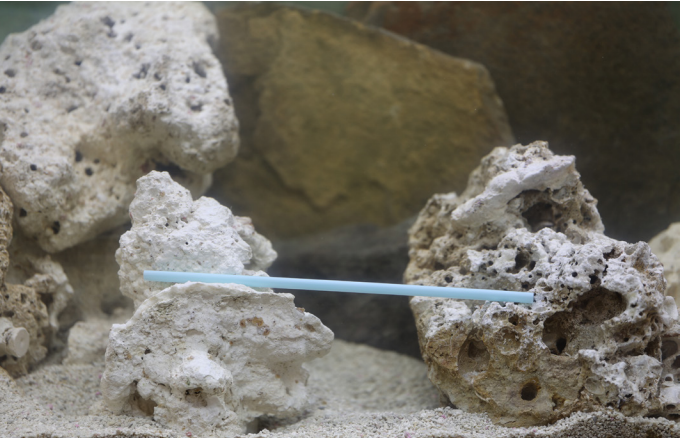
<p>First day of the straw in the tank.</p>
<p><b>4/16/21</b></p>

On April 2 the first of the randomly selected phade straws was placed on top of the water in Tank 2, after which it immediately sank to the bottom (unlike other traditionally manufactured straws). The straw was then placed on the rocks by Keypoint Intelligence technicians.

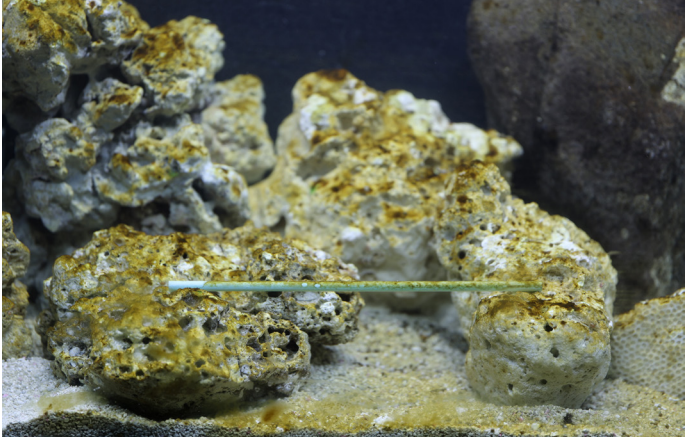
<p>The straw exhibited some degradation, and algae began forming along the rocks.</p>	<p><b>4/16/21</b></p>

By April 12-13, the first signs of biodegradation on both straws (see Supporting Test Data for all photos) had already become evident, roughly seven days following the straws being added to the tanks. By April 22, technicians observed a buildup of algae beginning to form in both tanks, represented by a bright mustard yellow and rust coloring on the rocks as well as the sand on the bottom of the tank and even on the phade straw itself. This rapid buildup was likely caused from the consistent lighting that was required to capture photos of both tanks every five minutes, 24 hours a day, seven days a week (the presence of consistent light can foster rapid algae growth in a marine tank). Once observed, technicians notified WinCup of the issue and recommended adding two marine snails to Tank 2, and one to Tank 1. The snails consumed the algae and allowed the rocks and sand to regain their original color (their presence can be seen in the video). It should also be noted that the disappearance of the algae on the phade straw came from the biodegradation process (bacteria consuming the straw as well as the algae on the straw) and not from the snails. While the snails did occasionally bump the straws in both tanks, they did not attempt to eat the algae off the straw. Aside from the use of a magnetic aquarium glass cleaner to minimize any contamination in the tank's front glass, no chemicals or other water clarifiers were added to the tank.

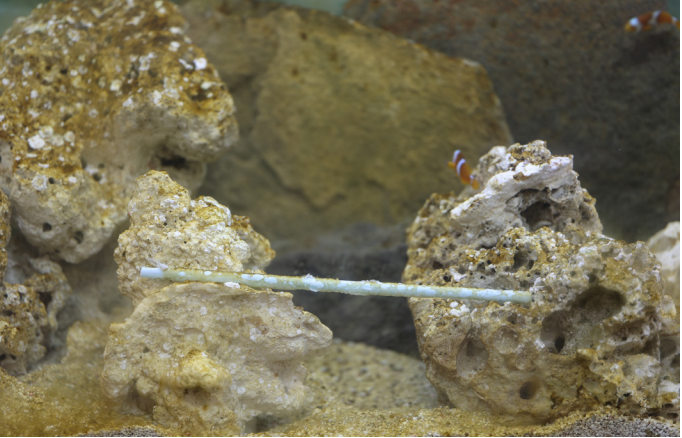
<p>The straw exhibited some degradation, and algae began forming along the rocks.</p>

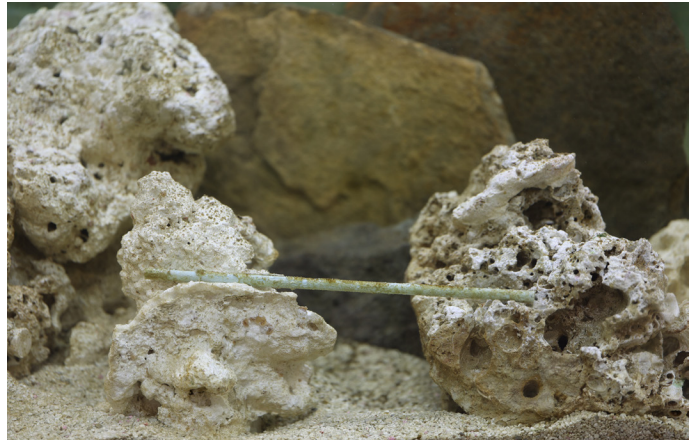
**4/30/21**

Algae was now under control, with the straw visibly intact but continuing to degrade at a steady pace.

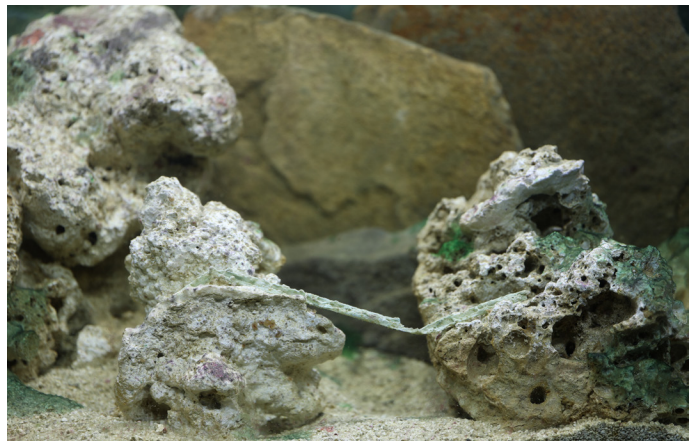
**5/14/21**

The straw is barely intact, with very evident degradation.

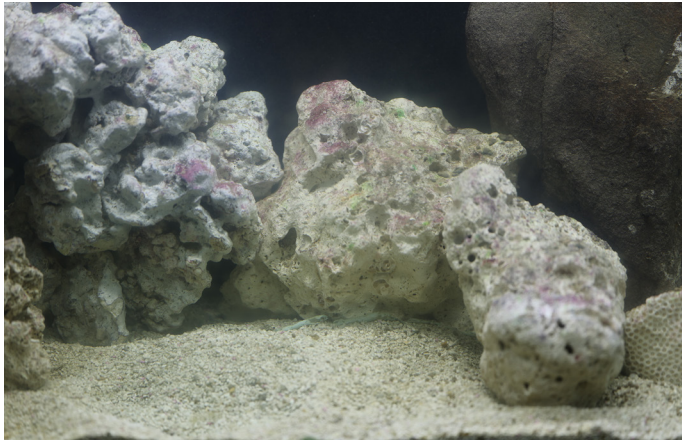
The straw had now collapsed from the rocks it was mounted on, and remnants can be seen just beneath the rock in the center of the frame.

On May 20, the straw in Tank 1 broke into two pieces as a result of the biodegradation process (bacteria consuming the phade straw). Upon falling to the floor of the tank, the current in the tank from the pumps pushed the straw under one of the rocks in the back of the tank, which caused the view of the straw to be almost completely blocked from the camera. Keypoint Intelligence and WinCup decided the rock in the front left of the tank should be removed (May 24) so that a better view could be established of the straw completing biodegradation. As the rock was removed, the team changed the timing on the photography from one shot every five minutes to one shot every five

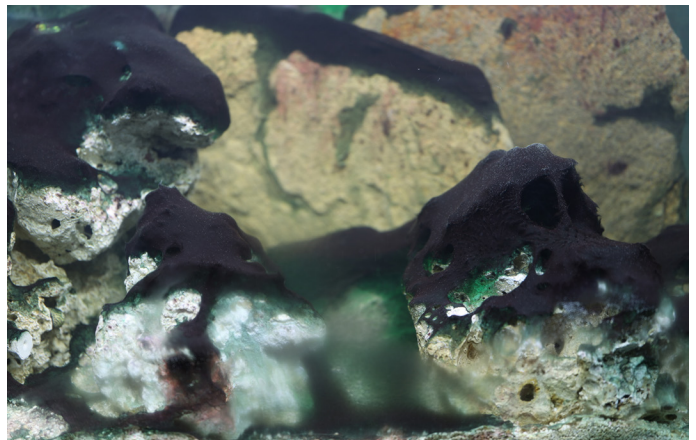
**6/7/21**

No remnants of the straw are visible.

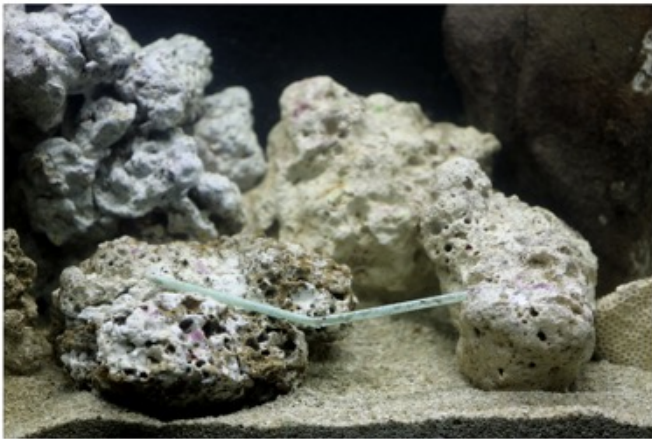
**G80A2924 (2).JPG**

**Day 45, May 20, 2021, 9:24 pm:**  
First break in straw.

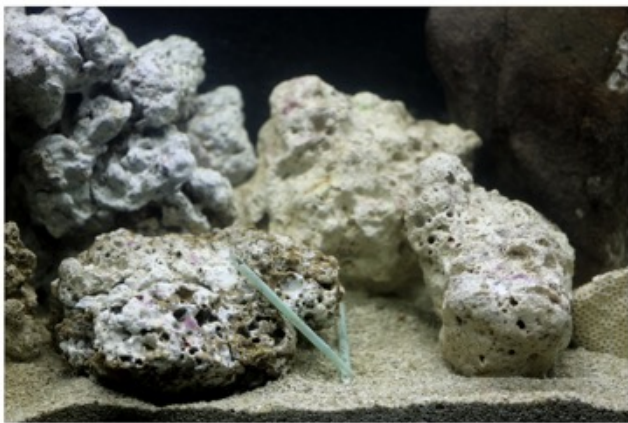
**G80A2937.JPG**

**Day 45: May 20, 2021, 10:29 pm:**  
Complete break of straw

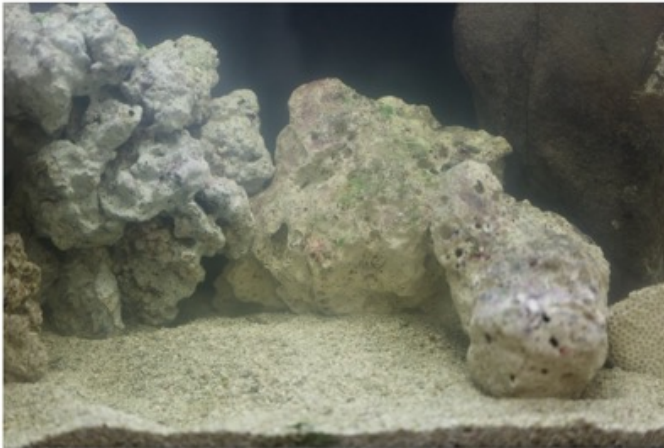
**G80A6559.JPG**

**Day 58: June 2, 2021, 7:34 am:**  
 Straw is completely gone.

seconds to capture the action—at no point in this process was the straw touched. A technician simply removed the rock and the photography was adjusted back to one shot every five minutes, enabling a much better and cleaner view of the final states of biodegradation and allowing for irrefutable evidence of the complete biodegradation of the phade PHA Marine Biodegradable straw on Day 58.

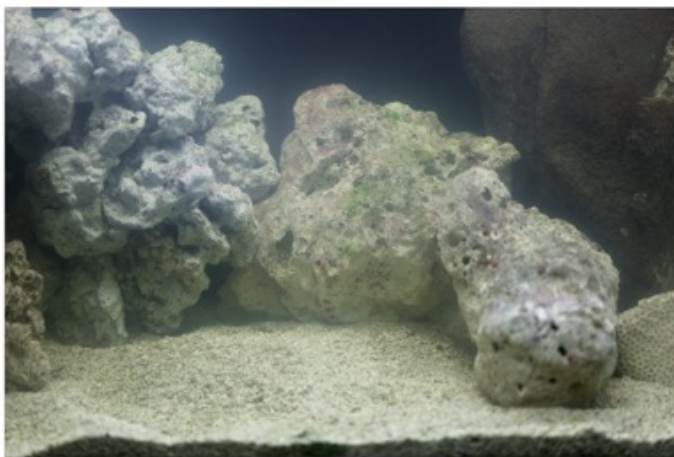
**G80A6756.JPG**

**Day 58, June 2, 2021, 11:59 pm:**  
Final frame.
